**Flood Control Project Maintenance
Levee Inspections**

Fall 2015 Levee Maintenance Deficiency Summary Report

Sacramento River Basin

Lake County Watershed Protection District

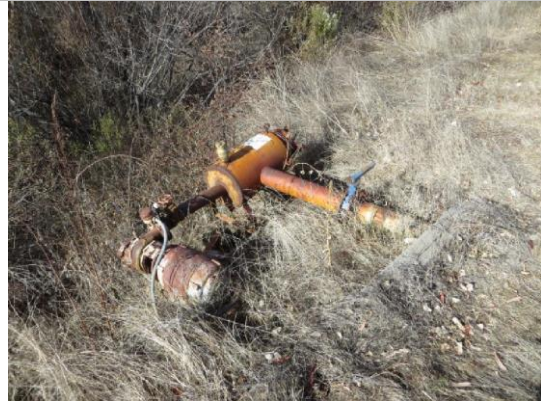
Photo 3 of 3 : UCIP_FA_2015_3429.jpg

LM Start	0.56	Rating **	M	Issue No.	535 (cont)
LM End	0.56	Issue Type +	En	Location *	LS
Category	Supplemental			GPS Latitude/Longitude	
				Start	End
Item	DWR UCIP Field Study			39.183519 °	39.183519 °
				-122.911379 °	-122.911379 °
DWR ID					
Action/Comments					
Inspector Comments: FS_ID:26943					
DS_ID:21193					
EP_NO: 5237					
FS_HLM: 0.558					
Repair Type: Non-Urgent					
Crossing Status: Found

Pump and butterfly valve on WS berm.

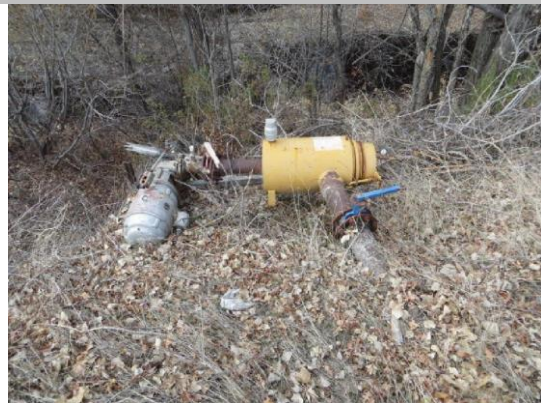
Photo 1 of 3 : UCIP_FA_2015_3439.jpg

LM Start	0.84	Rating **	M	Issue No.	536
LM End	0.84	Issue Type +	En	Location *	LS
Category	Supplemental			GPS Latitude/Longitude	
				Start	End
Item	DWR UCIP Field Study			39.179534 °	39.179534 °
				-122.912512 °	-122.912512 °
DWR ID					
Action/Comments					
Inspector Comments: FS_ID:26946 DS_ID:21196 EP_NO: N/A FS_HLM: 0.845 Repair Type: Non-Urgent Crossing Status: Found UCIP Comments: Pump and pipe appear abandoned and should be done so properly. FIELD_STRUCT_DESC: 8-inch steel irrigation pipe through the levee, 3.0 feet below the crown. Siphon breaker in 24-inch CMP riser on landward slope. Pump on the waterward bank with a butterfly valve. Service pole on the waterward berm. (USACE-1961). This entry matches the Drainage or Irrigation Structure referenced in O&M manual (HLM 0.83). FS Date: 01/09/2014

Pump and butterfly valve visible on WS berm.

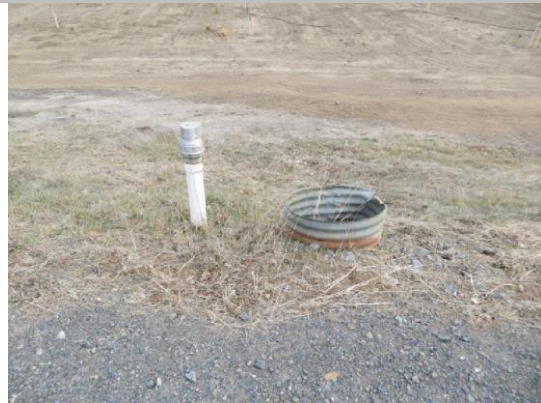
Photo 3 of 3 : UCIP_FA_2015_3441.jpg

Inspector Comments: FS_ID:26946
 DS_ID:21196
 EP_NO: N/A
 FS_HLM: 0.845
 Repair Type: Non-Urgent
 Crossing Status: Found
 UCIP Comments: Pump and pipe appear abandoned and should be done so properly.
 FIELD_STRUCT_DESC: 8-inch steel irrigation pipe through the levee, 3.0 feet below the crown. Siphon breaker in 24-inch CMP riser on landward slope. Pump on the waterward bank with a butterfly valve. Service pole on the waterward berm. (USACE-1961). This entry matches the Drainage or Irrigation Structure referenced in O&M manual (HLM 0.83).
 FS Date: 01/09/2014

Siphon breaker in 24-inch cmp riser with vent on LS shoulder.

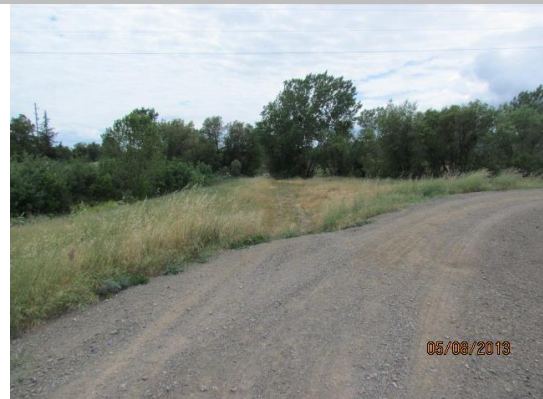
Photo 1 of 1 : FA_2015_NA0009_3_13_20150910_00007.jpg

LM Start	2.29	Rating **	M	Issue No.	13
LM End	2.29	Issue Type +	Ma	Location *	WS
Category	Earthen Levee			GPS Latitude/Longitude	
				Start	End
Item	Slope Stability			39.160285 °	39.160285 °
				-122.913481 °	-122.913481 °
DWR ID	DWR_NA0009_01_s_2013_13				
Action/Comments					
Repair the levee slope damaged by vehicle traffic and prevent access where possible.

View of the vehicle erosion along the waterside slope.

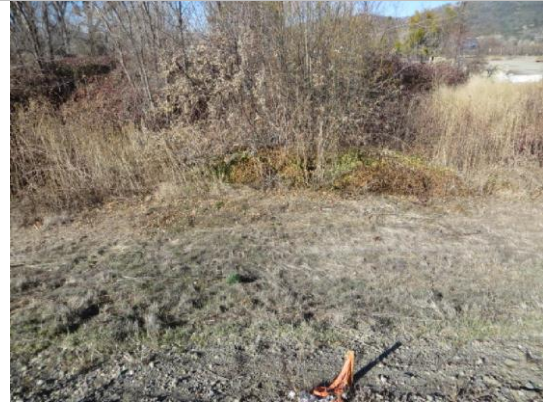
Photo 3 of 3 : UCIP_FA_2015_3471.jpg

Action/Comments					
Inspector Comments: FS_ID:27004 DS_ID:21199 EP_NO: 11460 FS_HLM: 2.353 Repair Type: Non-Urgent Crossing Status: Found UCIP Comments: Heavy vegetation on LS at inlet should be removed. FIELD_STRUCT_DESC: 42-inch CM drainpipe through the levee, 10.0 feet below the crown. Flap gate on waterward end. Concrete headwall on both ends. Originally included in 1961 O+M manual. Pipe retained under ABO No. 11460 (1975). FS Date: 01/14/2014

Heavy vegetation at inlet on LS toe.

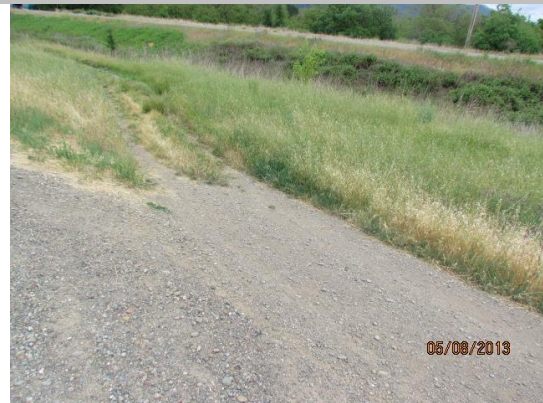
Photo 1 of 1 : FA_2015_NA0009_3_14_20150910_00008.jpg

LM Start	2.36	Rating **	M	Issue No.	14
LM End	2.36	Issue Type +	Ma	Location *	WS
Category	Earthen Levee			GPS Latitude/Longitude	
				Start	End
Item	Slope Stability			39.161153 °	39.161153 °
				-122.912740 °	-122.912740 °
DWR ID	DWR_NA0009_01_s_2013_14				
Action/Comments					
Repair the levee slope damaged by vehicle traffic and prevent access where possible.

View of the vehicle erosion along the waterside slope.

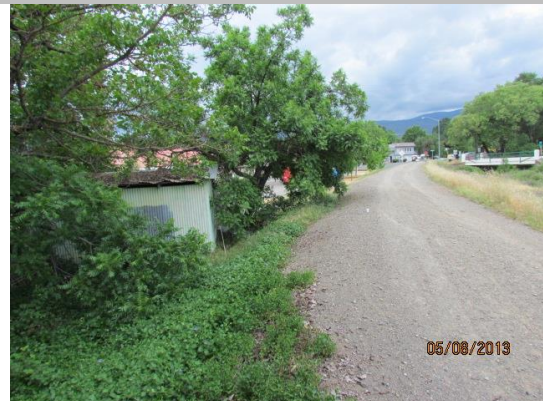
Photo 1 of 1 : FA_2015_NA0009_3_15_20150910_00009.jpg

LM Start	2.38	Rating **	M	Issue No.	15
LM End	2.41	Issue Type +	Ma	Location *	LS
Category	Earthen Levee			GPS Latitude/Longitude	
				Start	End
Item	Trim / Thin Trees			39.161381 °	39.161708 °
				-122.912551 °	-122.912168 °
DWR ID	DWR_NA0009_01_s_2013_15				
Action/Comments					
Trim trees to at least five feet above ground level.

Trim the trees up 5 feet to allow visibility.

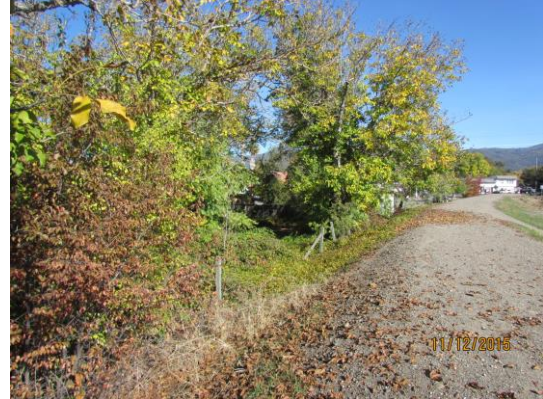
Photo 1 of 1 : FA_2015_NA0009_3_23_20151112_00021.jpg

View of the vegetation along the landside slope & toe.

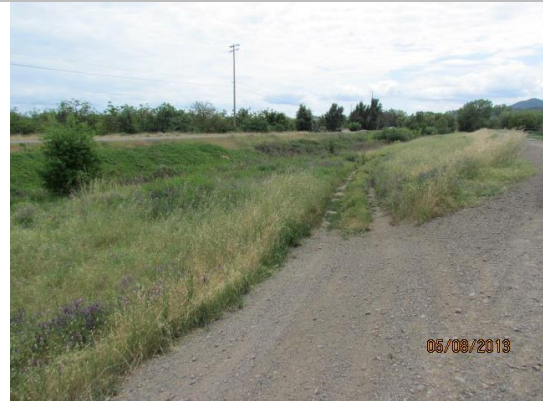
Photo 1 of 1 : FA_2015_NA0009_3_16_20150910_00010.jpg

LM Start	2.40	Rating **	M	Issue No.	16
LM End	2.40	Issue Type +	Ma	Location *	WS
Category	Earthen Levee			GPS Latitude/Longitude	
				Start	End
Item	Slope Stability			39.161601 °	39.161601 °
				-122.912303 °	-122.912303 °
DWR ID	DWR_NA0009_01_s_2013_16				
Action/Comments					
Repair the levee slope damaged by vehicle traffic and prevent access where possible.

View of the vehicle erosion along the waterside slope.

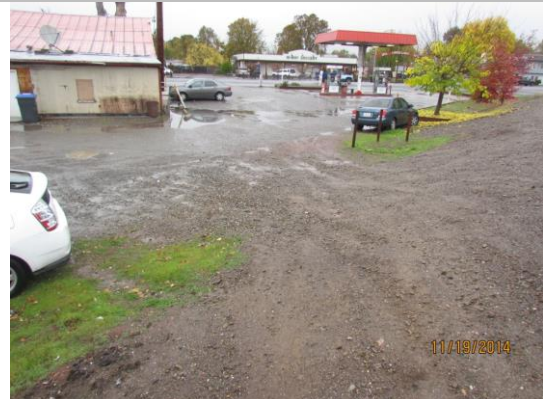
Photo 1 of 1 : FA_2015_NA0009_3_17_20150910_00011.jpg

LM Start	2.42	Rating **	M	Issue No.	17
LM End	2.42	Issue Type +	Ma	Location *	LS
Category	Earthen Levee			GPS Latitude/Longitude	
				Start	End
Item	Slope Stability			39.161802 °	39.161802 °
				-122.912020 °	-122.912020 °
DWR ID	DWR_NA0009_01_s_2013_17				
Action/Comments					
Repair the levee slope damaged by vehicle traffic and prevent access where possible.

View of the erosion caused by vehicle along the landside slope.

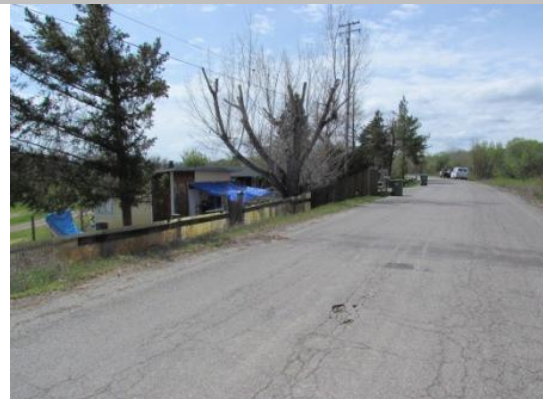
Photo 1 of 1 : FA_2015_NA0009_3_4_20150910_00002.jpg

View of the fences at the Landside toe.

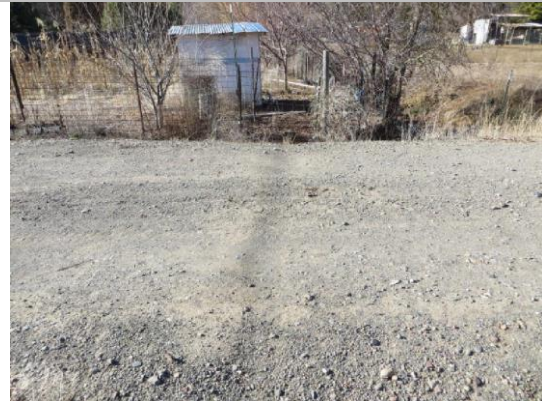
Photo 1 of 3 : UCIP_FA_2015_3121.jpg

LM Start	0.48	Rating **	M	Issue No.	20
LM End	0.48	Issue Type +	En	Location *	LS
Category	Supplemental			GPS Latitude/Longitude	
				Start	End
Item	DWR UCIP Field Study			39.184080 °	39.184080 °
				-122.912130 °	-122.912130 °
DWR ID					
Action/Comments					
Inspector Comments: FS_ID:27563 DS_ID:24761 EP_NO: N/A FS_HLM: 0.48 Repair Type: Non-Urgent Crossing Status: Found UCIP Comments: No Permit identified for crossing. FIELD_STRUCT_DESC: 1.5-inch HDPE irrigation pipe through the levee at unknown depth below the crown. Pipe visible on WS berm slope. Pumphouse on LS toe. FS Date: 01/14/2014

cut across levee crown visible along pipe alignment.

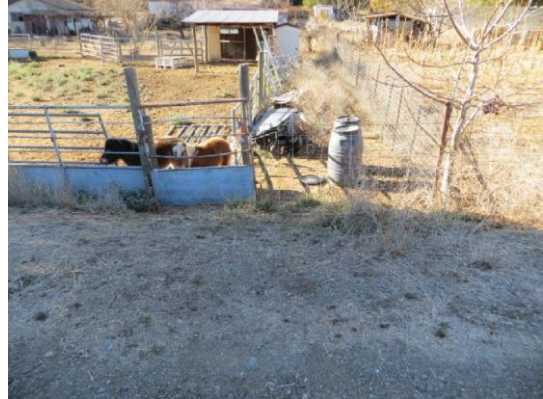
Photo 1 of 3 : UCIP_FA_2015_1200.jpg

LM Start	0.50	Rating **	U	Issue No.	21
LM End	0.50	Issue Type +	En	Location *	LS
Category	Supplemental			GPS Latitude/Longitude	
				Start	End
Item	DWR UCIP Field Study			39.183775 °	39.183775 °
				-122.912187 °	-122.912187 °
DWR ID					
Action/Comments					
Inspector Comments: FS_ID:43053					
DS_ID:21209					
EP_NO: 8513					
FS_HLM: 0.5					
Repair Type: Urgent					
Crossing Status: Found

Valves visible just off LS toe.

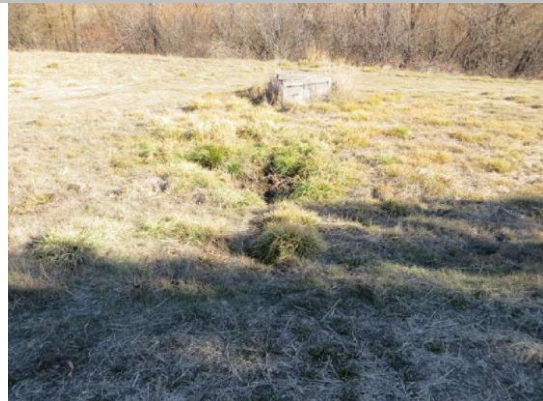
Photo 2 of 3 : UCIP_FA_2015_1201.jpg

Mudpit at WS berm were pipe may be leaking.

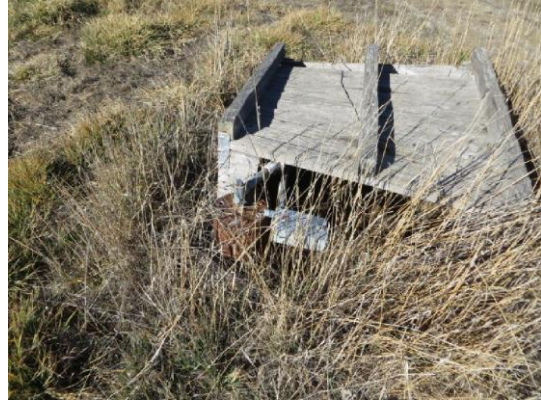
Photo 3 of 3 : UCIP_FA_2015_1202.jpg

LM Start	0.50	Rating **	U	Issue No.	21 (cont)
LM End	0.50	Issue Type +	En	Location *	LS
Category	Supplemental			GPS Latitude/Longitude	
				Start	End
Item	DWR UCIP Field Study			39.183775 °	39.183775 °
				-122.912187 °	-122.912187 °
DWR ID					
Action/Comments					
Inspector Comments: FS_ID:43053					
DS_ID:21209					
EP_NO: 8513					
FS_HLM: 0.5					
Repair Type: Urgent					
Crossing Status: Found

Pump and pipe visible at wooden box on WS berm.

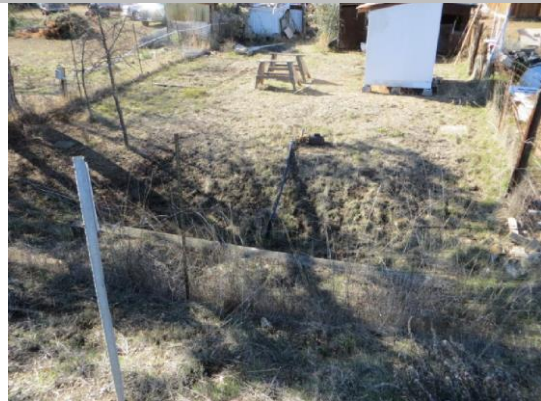
Photo 3 of 3 : UCIP_FA_2015_3474.jpg

Inspector Comments: FS_ID:27208
 DS_ID:21210
 EP_NO: 11482
 FS_HLM: 0.545
 Repair Type: Non-Urgent
 Crossing Status: Found
 UCIP Comments: Fence on LS slope creates access issue.
 FIELD_STRUCT_DESC: 36-inch CM drainpipe through the levee, 9.0 feet below the crown. Flap gate on the waterward end. Concrete headwalls on both ends. (USACE-1961). This entry matches the Drainage or Irrigation Structure referenced in O&M manual (HLM 0.54). This pipe was retained under ABO No. 11482 (1975).
 FS Date: 01/14/2014

Concrete headwall on LS toe.

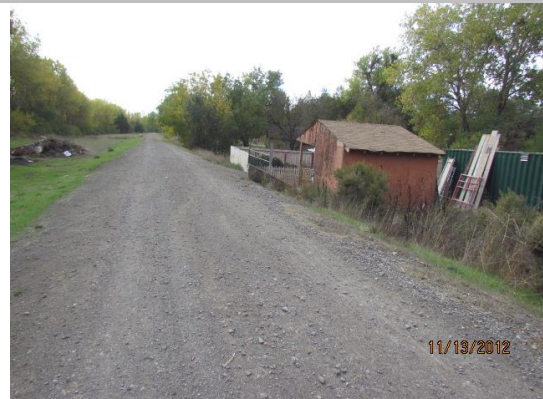
Photo 1 of 1 : FA_2015_NA0009_4_5_20150910_00005.jpg

View of building along the levee toe.

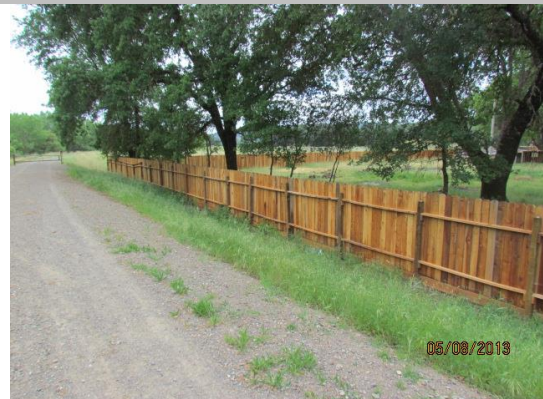
Photo 1 of 1 : FA_2015_NA0009_4_10_20150910_00008.jpg

View of the unauthorized fence along the landside toe.

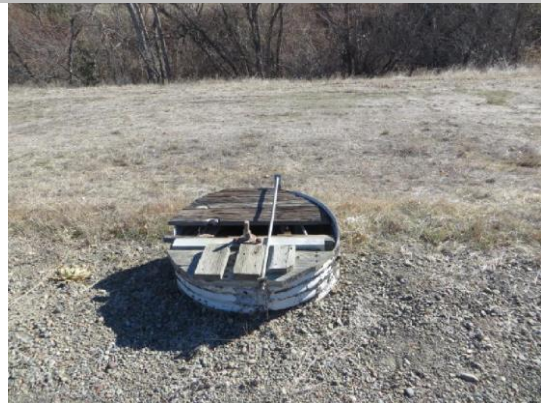
Photo 2 of 2 : UCIP_FA_2015_3061.jpg

Inspector Comments: FS_ID:42994
 DS_ID:21212
 EP_NO: 11483
 FS_HLM: 1.228
 Repair Type: Non-Urgent
 Crossing Status: Found
 UCIP Comments: Pipe appears abandoned and if so, should be done so properly. Debris blocking flapgate at outlet.
 FIELD_STRUCT_DESC: 30-inch CM drainpipe through the levee, 17.8 feet below the crown. Slide gate in 44-inch diameter CMP riser waterward slope. Flap gate on the waterward end at concrete headwall. 6'X8' concrete sump at landward toe. (USACE-1961). Originally included in O&M manual (HLM 1.22). This pipe was retained under ABO No. 11483 (1975).
 FS Date: 01/22/2014

Slide gate in 44-inch CMP riser on WS shoulder.

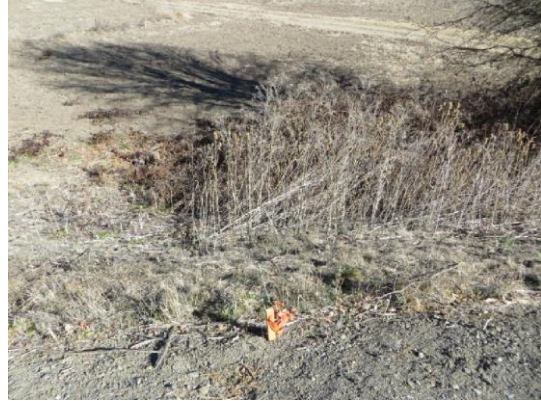
Photo 3 of 3 : UCIP_FA_2015_3365.jpg

Pipe visible at LS toe covered with vegetation.

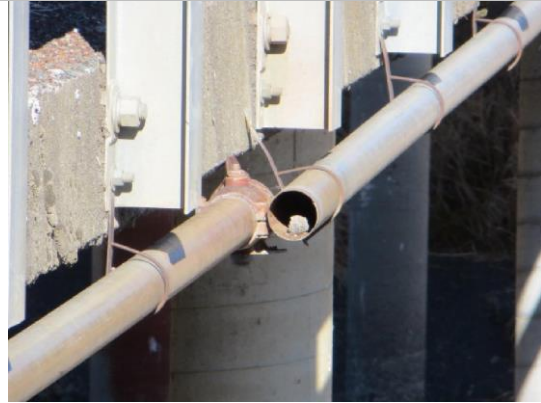
Photo 3 of 3 : UCIP_FA_2015_3423.jpg

Pipe open on waterward end.

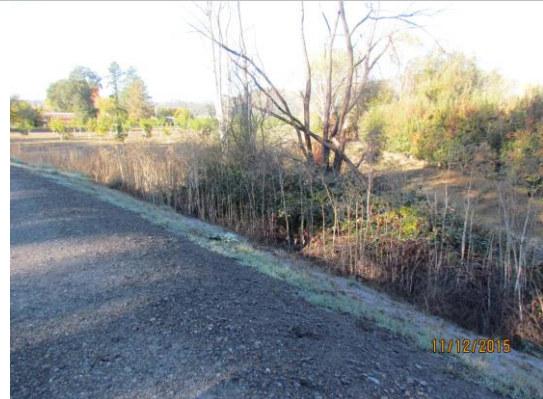
Photo 2 of 2 : FA_2015_NA0009_6_9_20151112_00005.jpg

View of the vegetation at the landside toe.

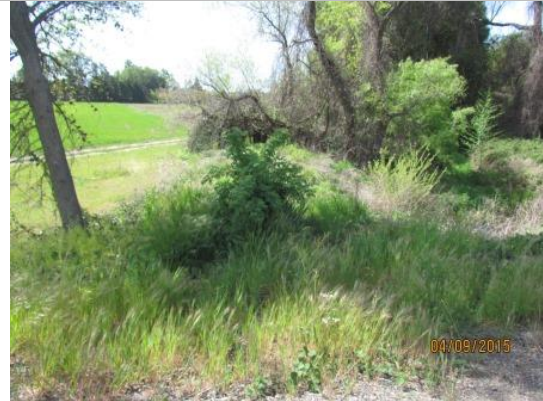
Photo 1 of 1 : FA_2015_NA0009_7_3_20150910_00001.jpg

View of the elderberry along the landside toe.
